July 5, 2024

Chelton, LLC
PO Box 460010
Fort Lauderdale, Florida 33487

Re: Former Kilmer Landfill Streambank Survey and Restoration
Technical Memorandum
Project Number 25237279

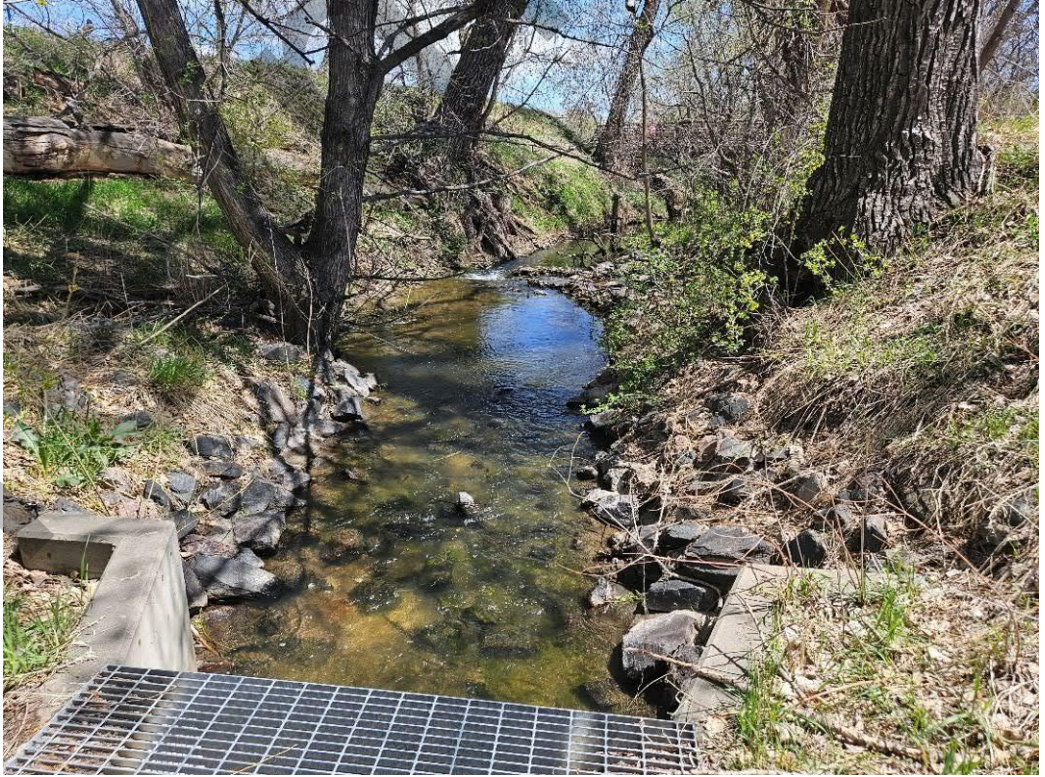
<p>Date: 4/24/2024</p>	
<p>Description: Viewing downstream from gauging station towards segments 1A (River Left) and 1B (River Right). Sections begin immediately downstream of the riprap.</p>

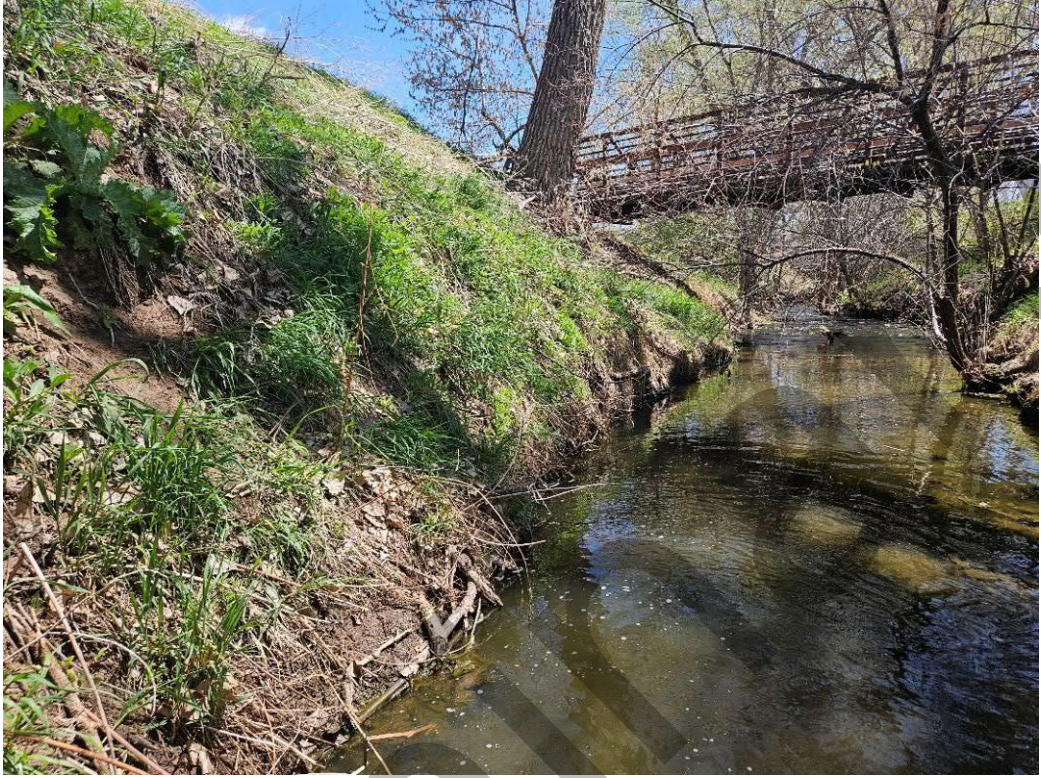
<p>Photo 3</p>

A photograph showing a stream flowing through a wooded area. The left bank is a steep, grassy embankment with some exposed roots. The water is dark and reflects the surrounding trees. A wooden bridge is visible in the background.
<p>Date: 4/24/2024</p>	
<p>Description: Facing downstream viewing segment 1A (left bank).</p>	
<p>Photo 4</p>

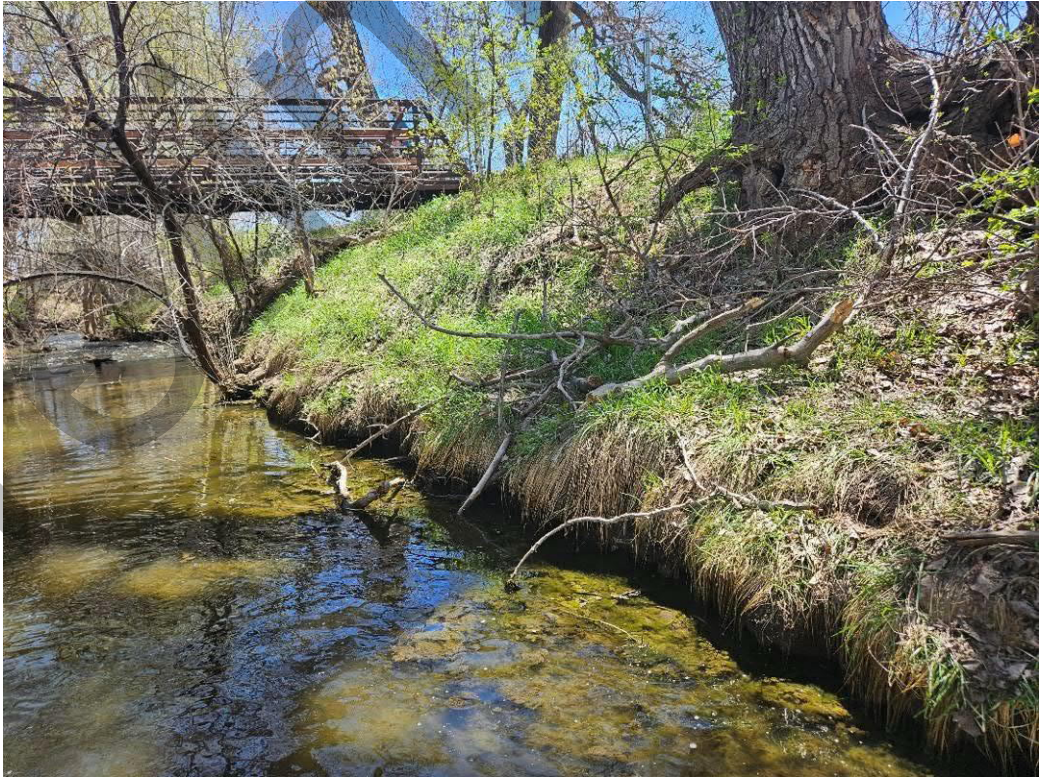
A photograph showing a stream flowing through a wooded area. The right bank is a steep, grassy embankment with many fallen branches and trees. The water is dark and reflects the surrounding trees. A wooden bridge is visible in the background.
<p>Date: 4/24/2024</p>	
<p>Description: Facing downstream viewing segment 1B (right bank)</p>

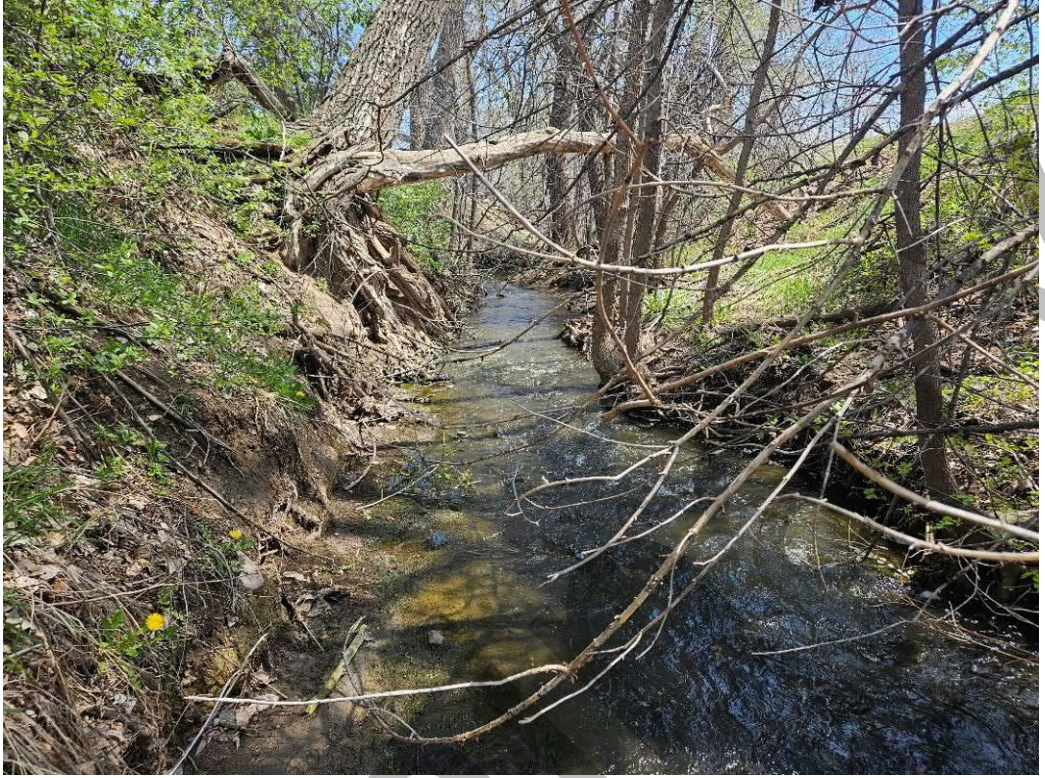
Photo 5

Date: 4/24/2024	
Description: Facing downstream viewing segments 2A on left and 1B continued on right.	
Photo 6

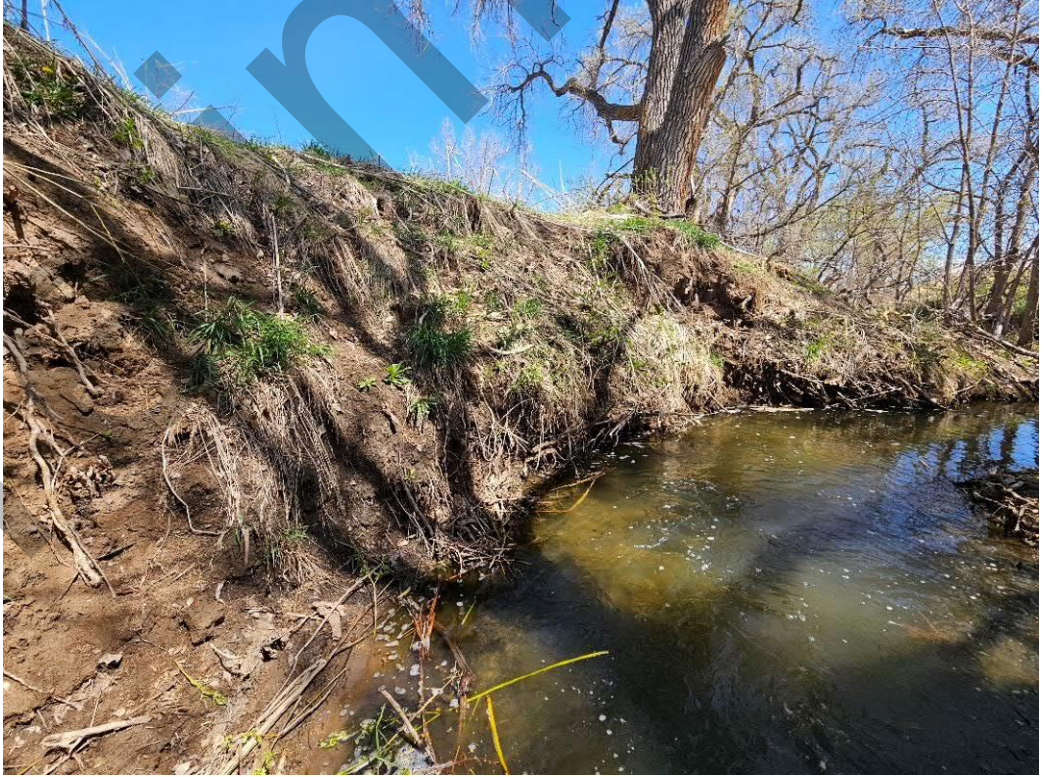
Date: 4/24/2024	
Description: Facing downstream viewing 3A.

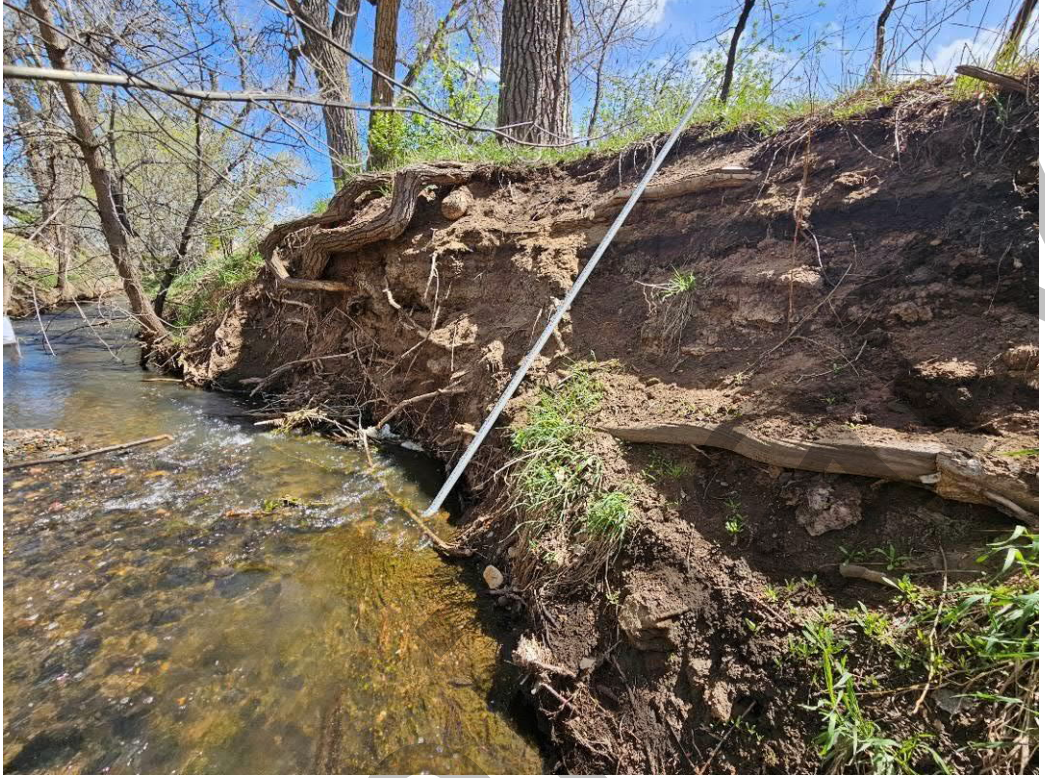
<p>Photo 7</p>

<p>Date: 4/24/2024</p>	
<p>Description: Facing downstream viewing 2B.</p>	
<p>Photo 8</p>

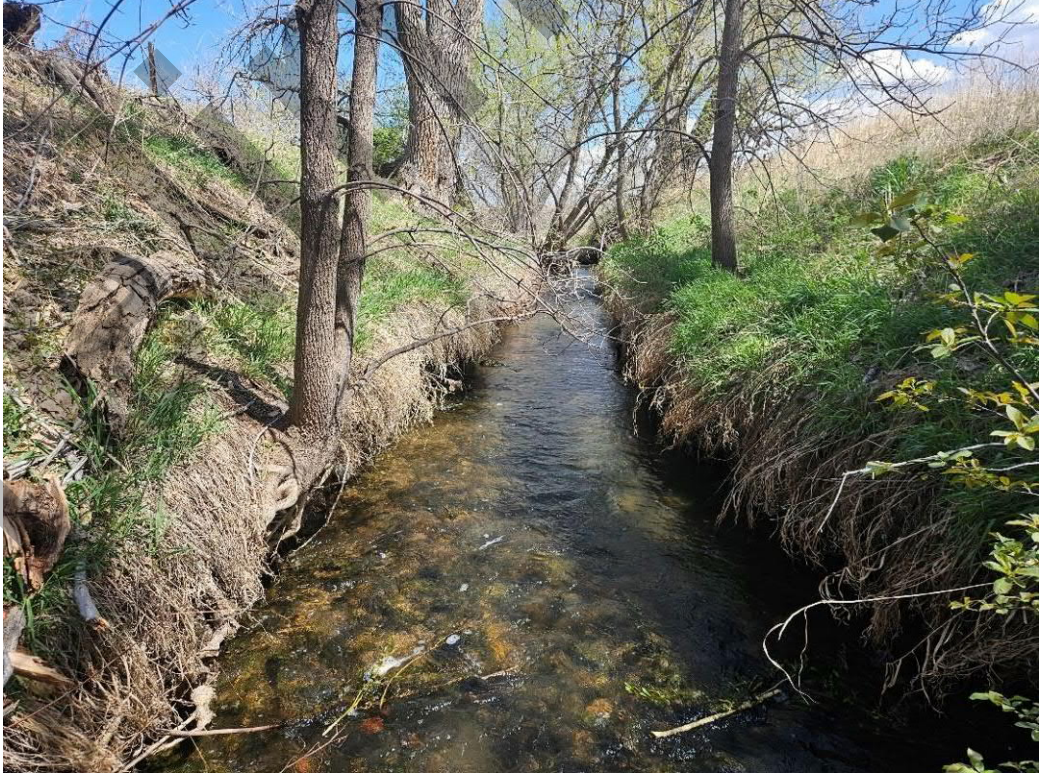
<p>Date: 4/24/2024</p>	
<p>Description: Facing upstream viewing 4A on right and 3B on left. Note undercut on 4A which resulted in a HIGH BANCS rating while 3B resulted in a MODERATE rating.</p>

A streambed lift was considered for the reaches below sections 4A and 3B. This would be a costly solution that would require additional studies, disturbance of adjacent property, and the installation of grade control features.

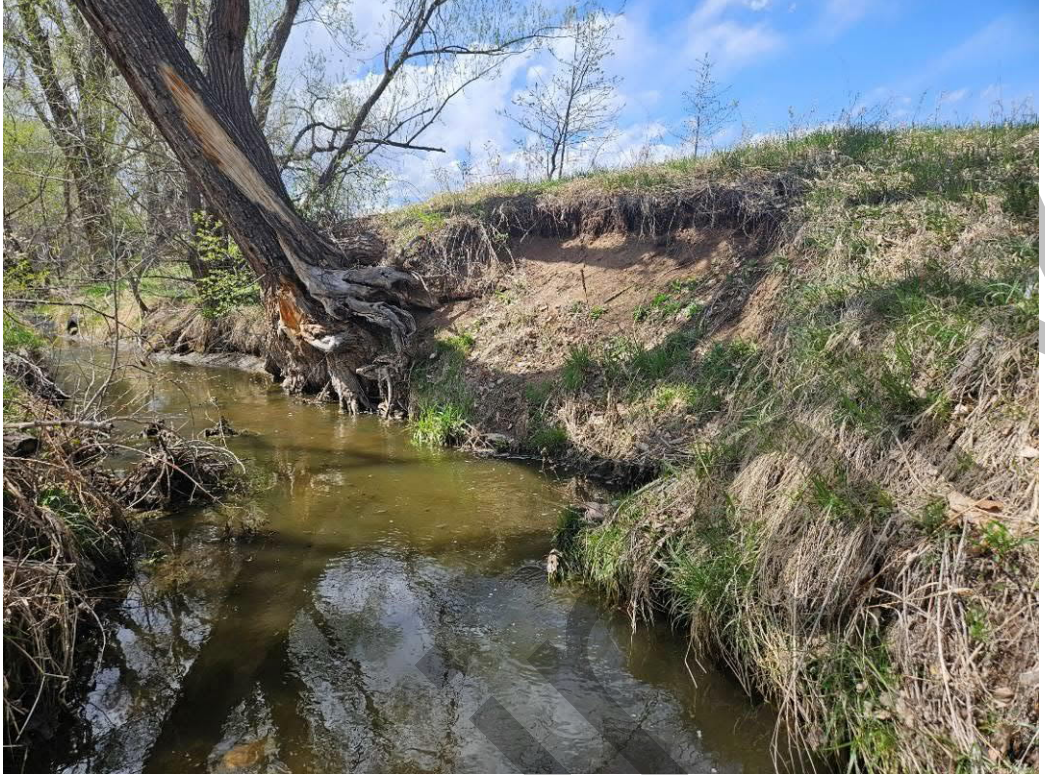
<p>Photo 9</p>

<p>Date: 4/24/2024</p>	
<p>Description: Facing upstream viewing 5A.</p>	
<p>Photo 10</p>

There are opportunities to provide the stream localized floodplain relief. The two sections include widening along the left bank near 5A through 9A. However, these sections include areas beyond the property limits owned by Chelton, LLC and would require removal of several mature trees. The right bank section near 5B could also be regraded and stabilized. Secondary adverse effects could occur at 5B like in previous stabilization attempts. This meander has a radius of curvature that is a lower value than what is considered stable for the reach. While this would not address the root causes of the source of instability, stabilizing this section would prevent further bank retreat as there are no mature trees along this section to prevent further degradation of the banks.

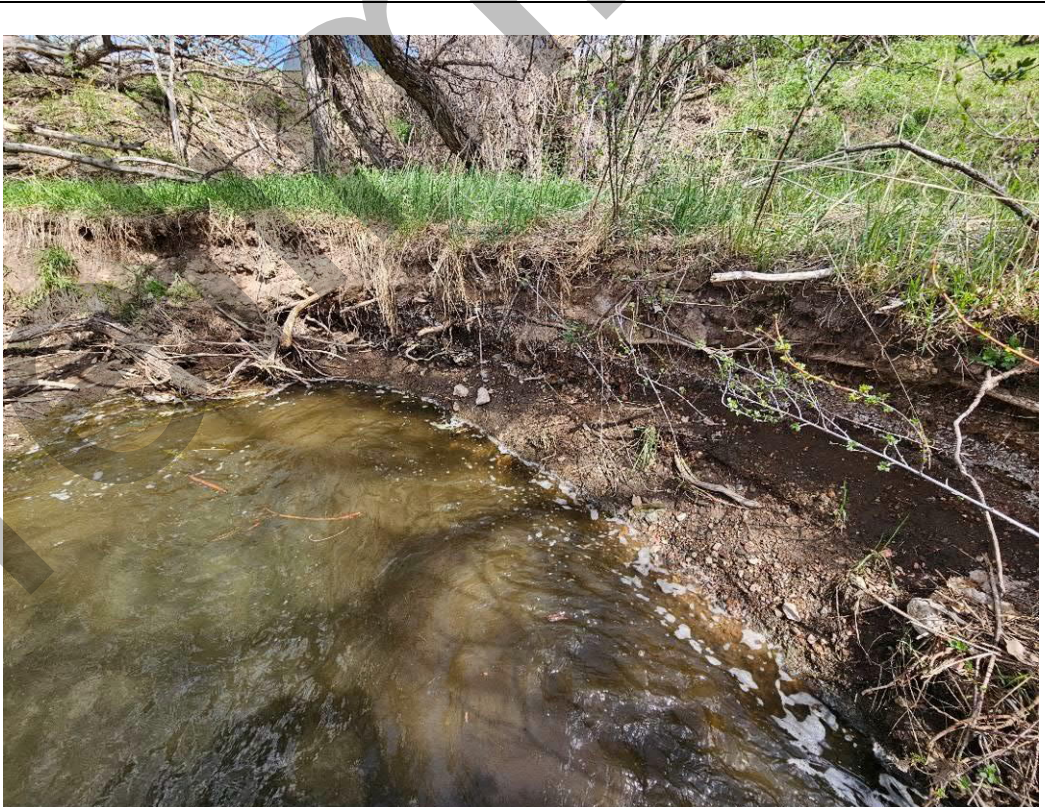
channel incision is causing an undercut in the banks. This is threatening the stability of the stabilization work and the biodegradable erosion control blankets are exposed. 5B has the most significant erosion within the previously repaired sections. Blankets along 5B were observed 4 feet above the water surface. Section 8A is stable and in good condition.

<p>Date: 4/24/2024</p>	
<p>Description: Facing downstream viewing 5B.</p>

Areas identified for stream bank improvements without impacting mature trees is limited. Section 5B could benefit from bank stabilization efforts including grading that would not significantly impact mature trees nor exacerbate the root causes identified. A larger segment of the study area could be improved by installing live stakes if plant establishment could occur prior to bank failure as seen in previous efforts.

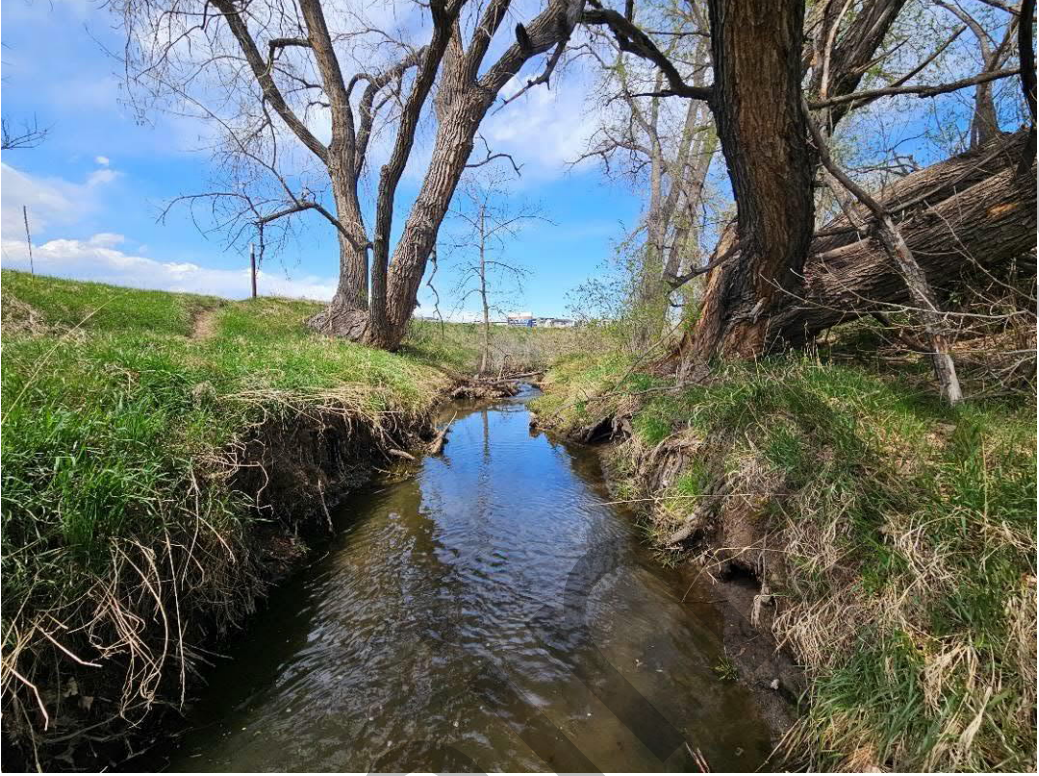
<p>Photo 11</p>

<p>Date: 4/24/2024</p>	
<p>Description: Facing downstream viewing segments 6A and 6B.</p>	
<p>Photo 12</p>

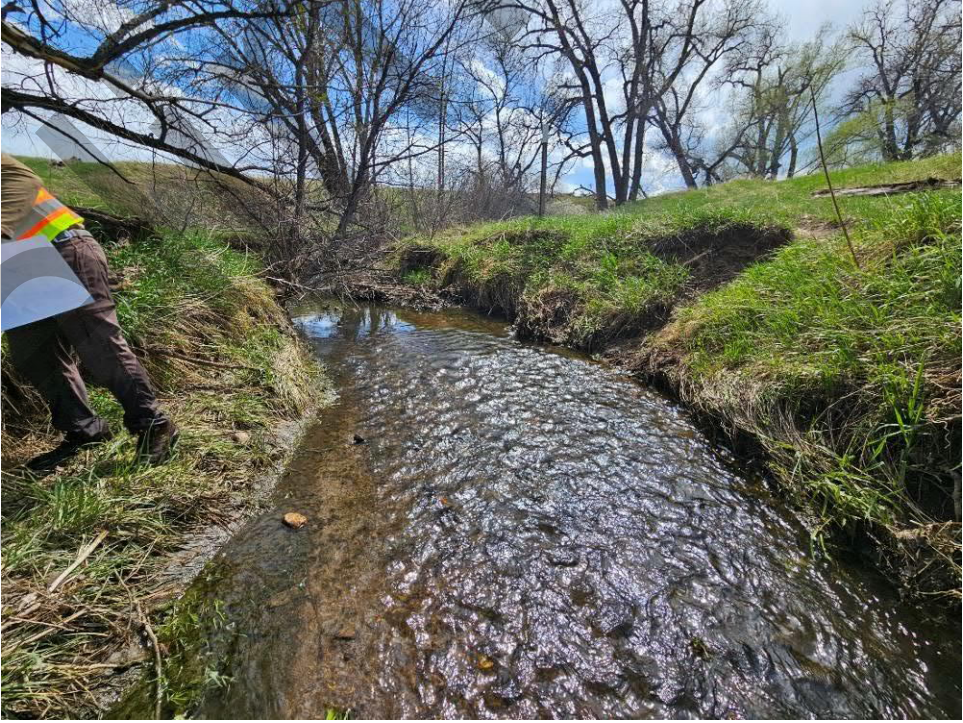
<p>Date: 4/24/2024</p>	
<p>Description: Facing upstream viewing 7A on the right.</p>

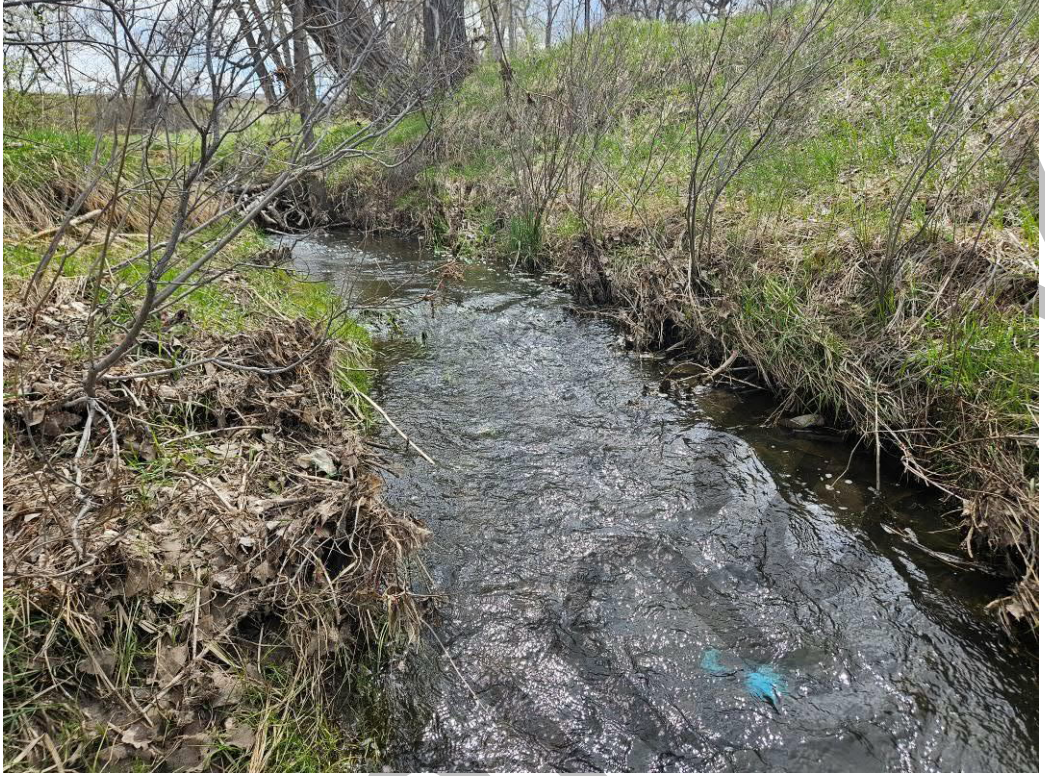
<p>Photo 13</p>

<p>Date: 4/24/2024</p>	
<p>Description: Facing upstream viewing transition from 7A to 8A (right).</p>	
<p>Photo 14</p>

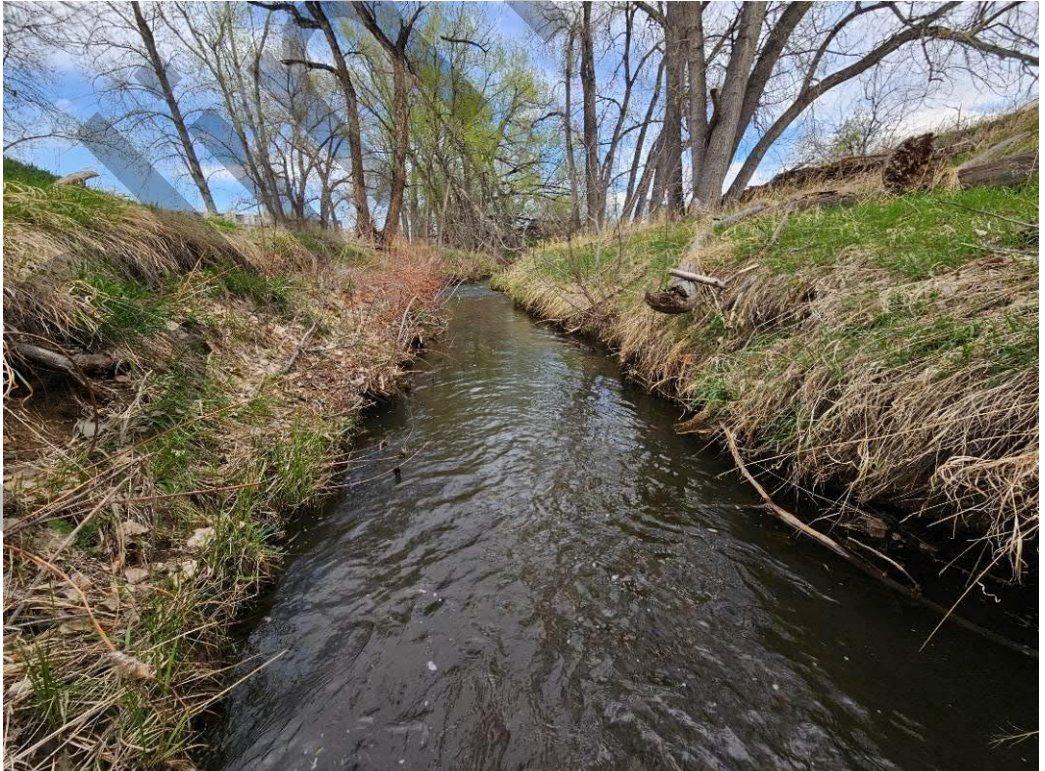
<p>Date: 4/24/2024</p>	
<p>Description: Facing upstream viewing 9A (right) and 6B (left). Note undercut on 9A and bank collapse on 6B. 9A is trending towards collapsing.</p>

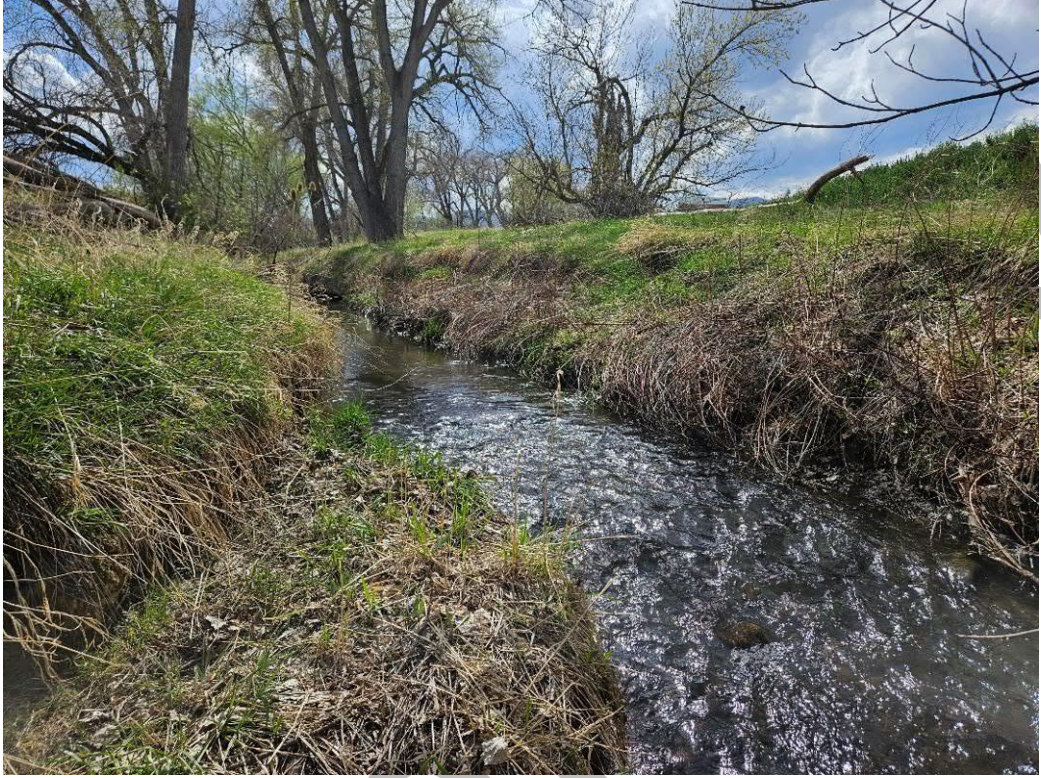
<p>Photo 15</p>

<p>Date: 4/24/2024</p>	
<p>Description: Facing upstream viewing the downstream end of 10A (right) and 6B (left)</p>	
<p>Photo 16</p>

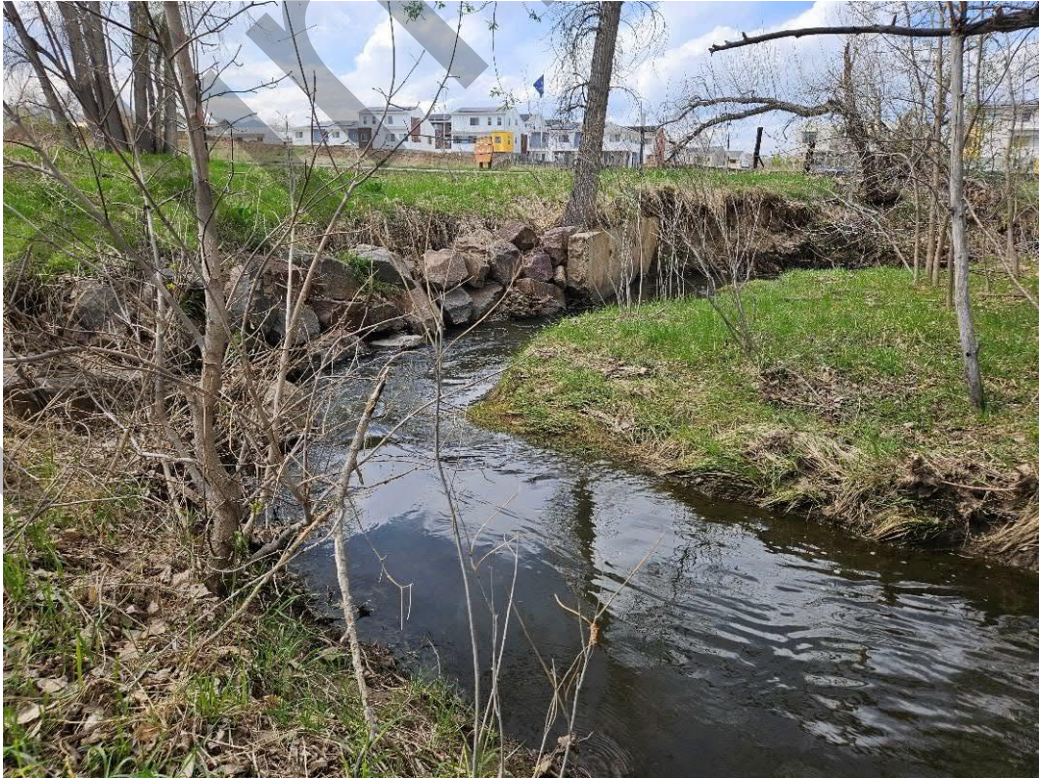
<p>Date: 4/24/2024</p>	
<p>Description: Facing downstream and viewing the terminus of the study reach.</p>

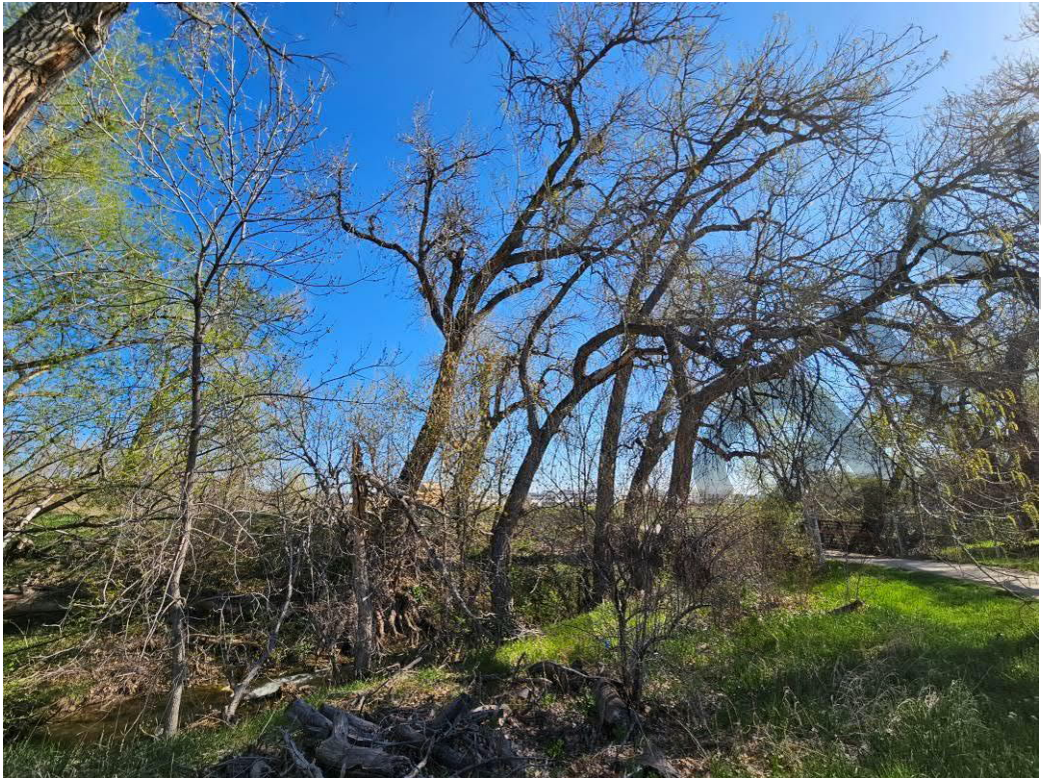
<p>Photo 17</p>	
<p>Date: 4/25/2024</p>	
<p>Description:</p> <p>Facing towards Ralston Creek and the pedestrian bridge at the upstream end of the study reach. Viewing example of numerous mature riparian trees present.</p>

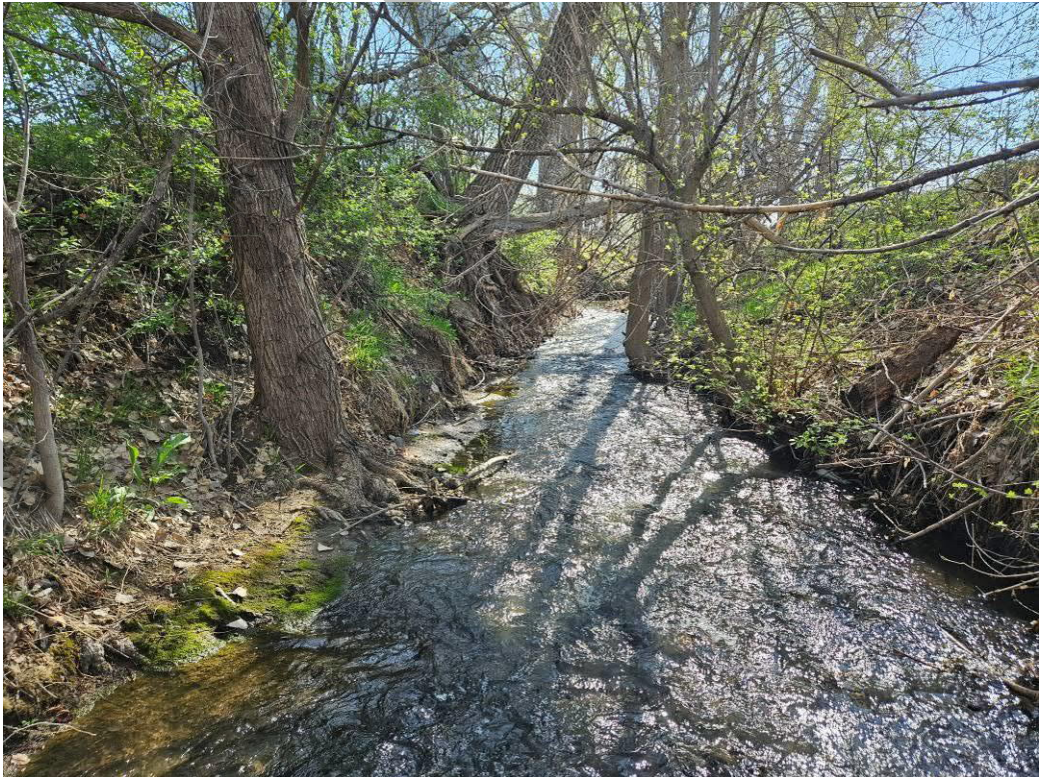
<p>Photo 18</p>	
<p>Date: 4/25/2024</p>	
<p>Description:</p> <p>Viewing example of soil retention mature trees are providing despite poor bank height ratio, bank angle, and erodible sandy soils.</p>

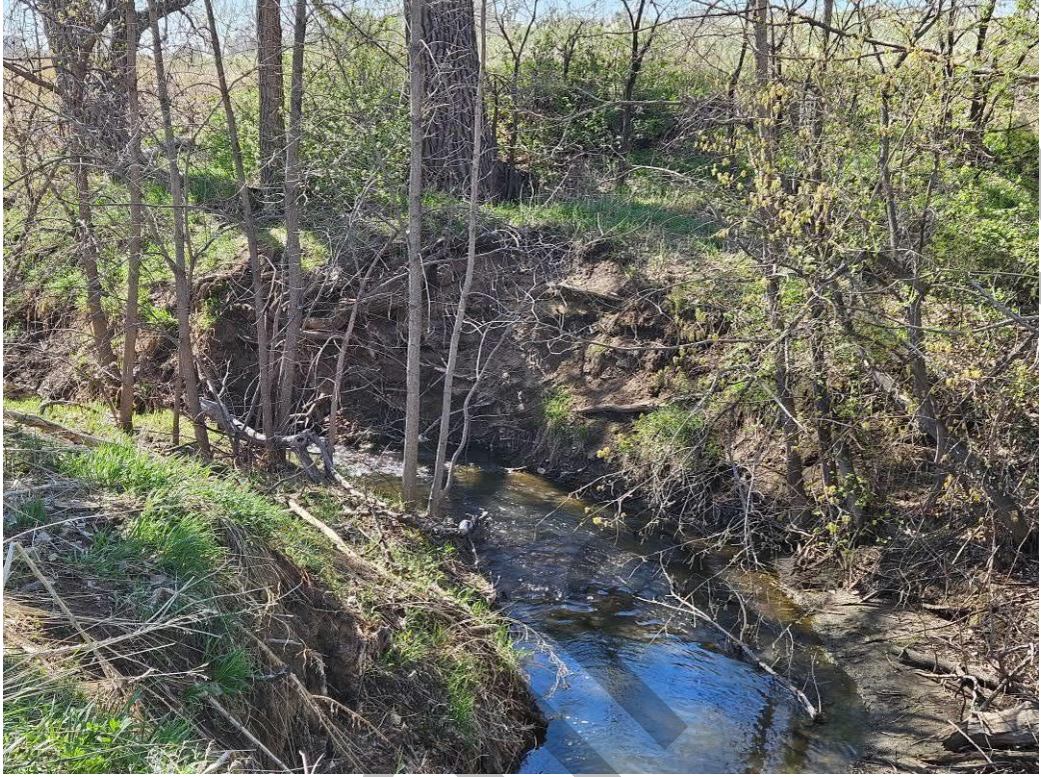
<p>Photo 19</p>	
<p>Date: 4/25/2024</p>	
<p>Description: Viewing eroded bank with dense root protection.</p>

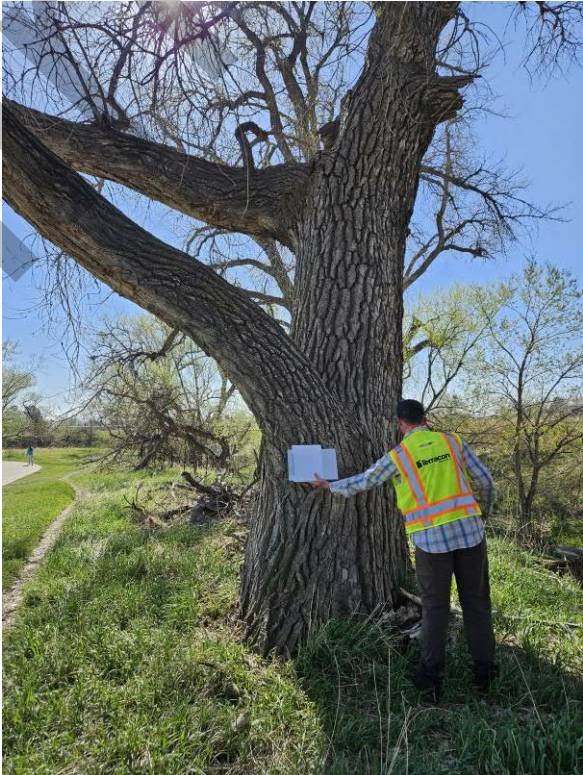
<p>Photo 20</p>	
<p>Date: 4/26/2024</p>	
<p>Description: Viewing specimen mature cottonwood tree.</p>

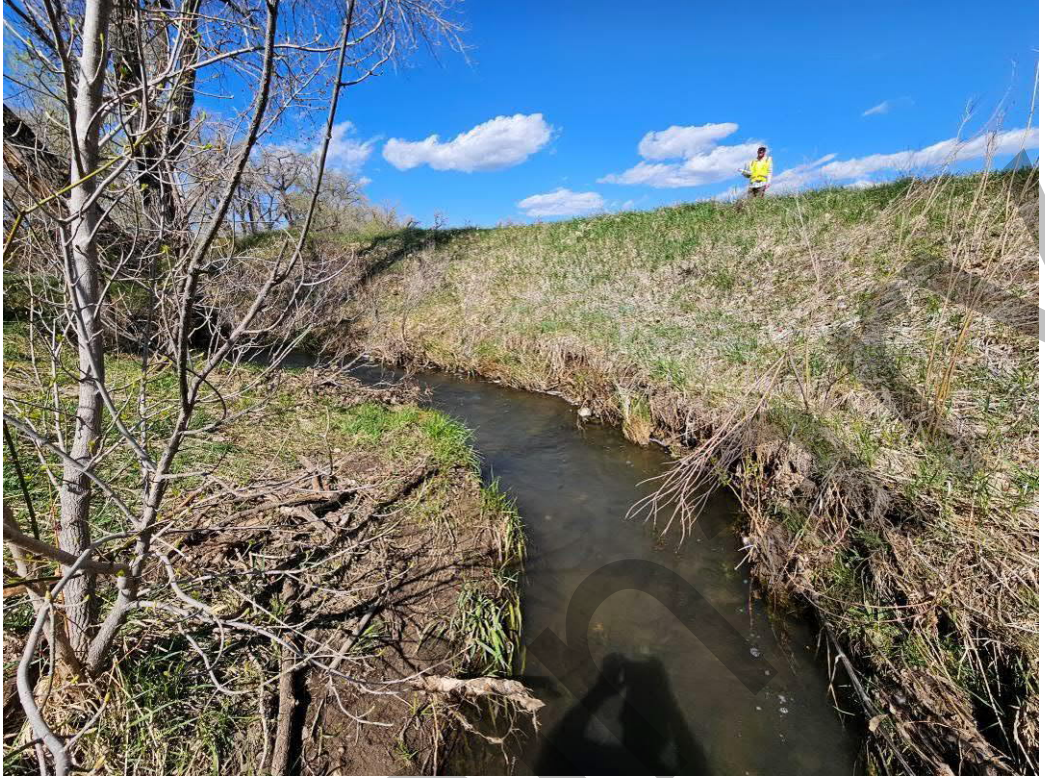
<p>Photo 21</p>

The previous installation and design of the improvements of the bank stabilization appear to be executed correctly. However, due to the root causes of degradation, these improvements are not functioning or at risk of failure in 3 of the 4 areas. Prior to visiting the site, bank treatments were discussed as potential mitigation for the bank degradation. It is the opinion of Terracon that these options would be unsuccessful due to the valley constraints. Any fill within the channel would further constrain the valley by reducing cross section width thereby increasing the energy and sediment transport within the channel and exacerbating the root causes. Grading the banks back at less steep stable slopes would obliterate the mature trees, and "spot fixes" would likely fail as did previous efforts to stem localized erosion.

<p>Date: 4/25/2024</p>	
<p>Description: Viewing failing previous bank stabilization efforts due to vertical channel incision and undercutting the bank stabilization from channel confinement.</p>	
<p>Photo 22</p>

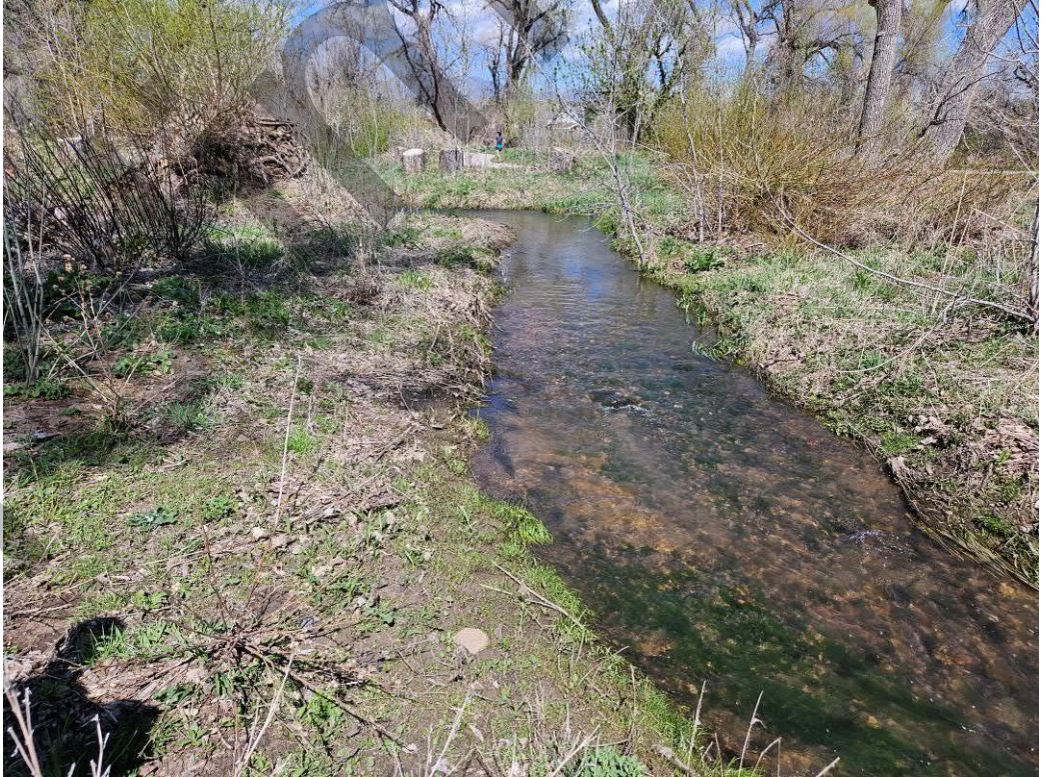
<p>Date: 4/25/2024</p>	
<p>Description: Viewing reference reach section upstream from Croke Canal.</p>
