PRELIMINARY ASSESSMENT

LANDFILL AT COTTONWOOD PARK

CERCLIS ID# CO0000309054

January 24, 1995

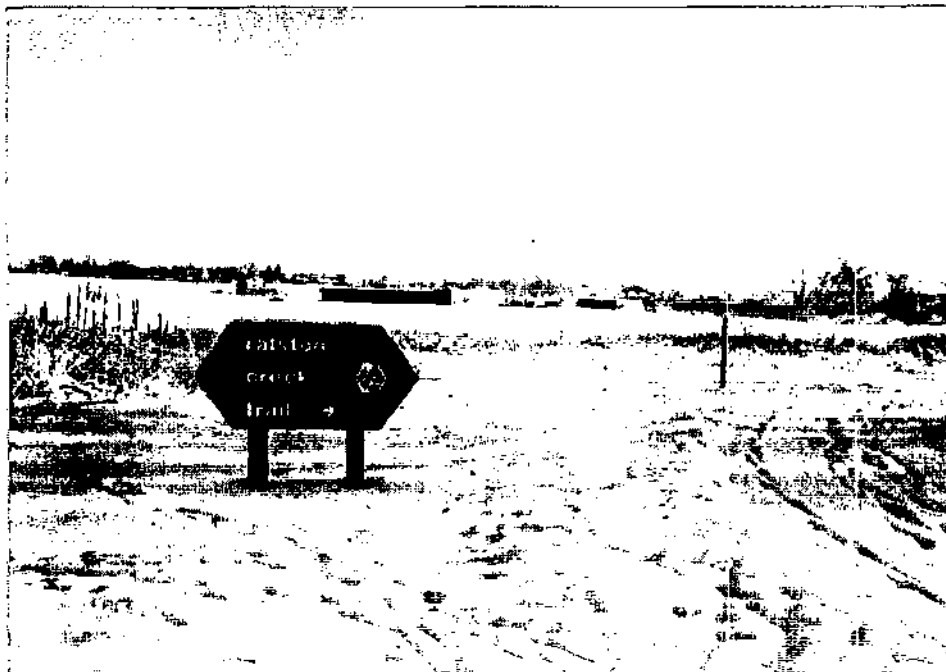
1

Description The Ralston Creek Trail lies parallel to Ralston Creek north of the site.

In the background is the northwest portion of Cottonwood West Industrial Park.

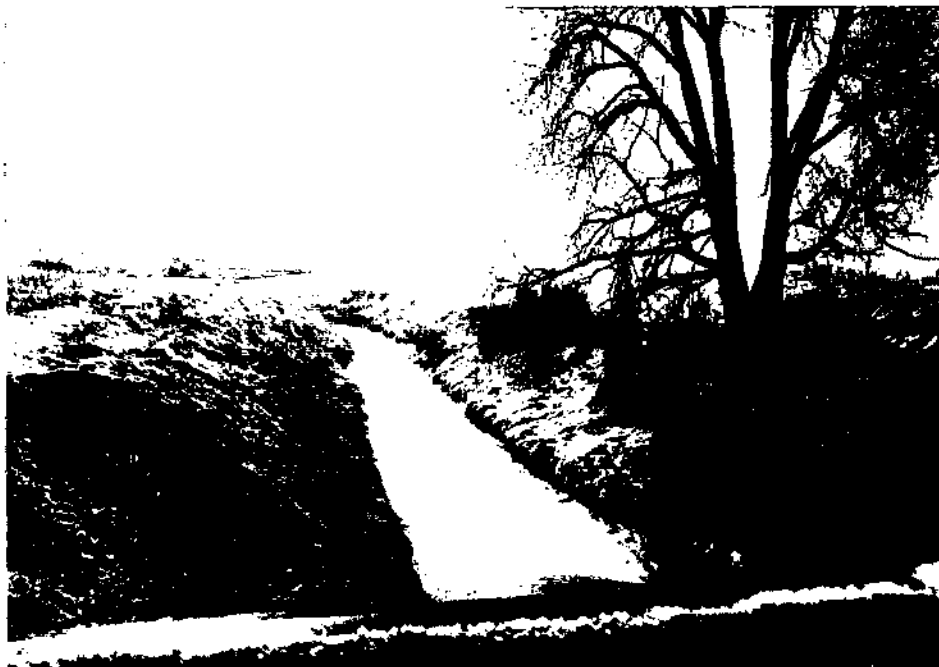
4

The Croke Canal bounds the landfill on the west and south (see Photo #4 in Appendix D). Water in the canal flows northward and enters Standley Lake approximately 9.5 miles downstream from the site. The mouth of the canal is approximately 3/4 mile from the Standley Lake dam outlet to Big Dry Creek. This creek flows northeasterly to the South Platte River (Odgen, 1991; USGS, 1980).
