#### 7.4 Ralston Creek Streambank Stabilization

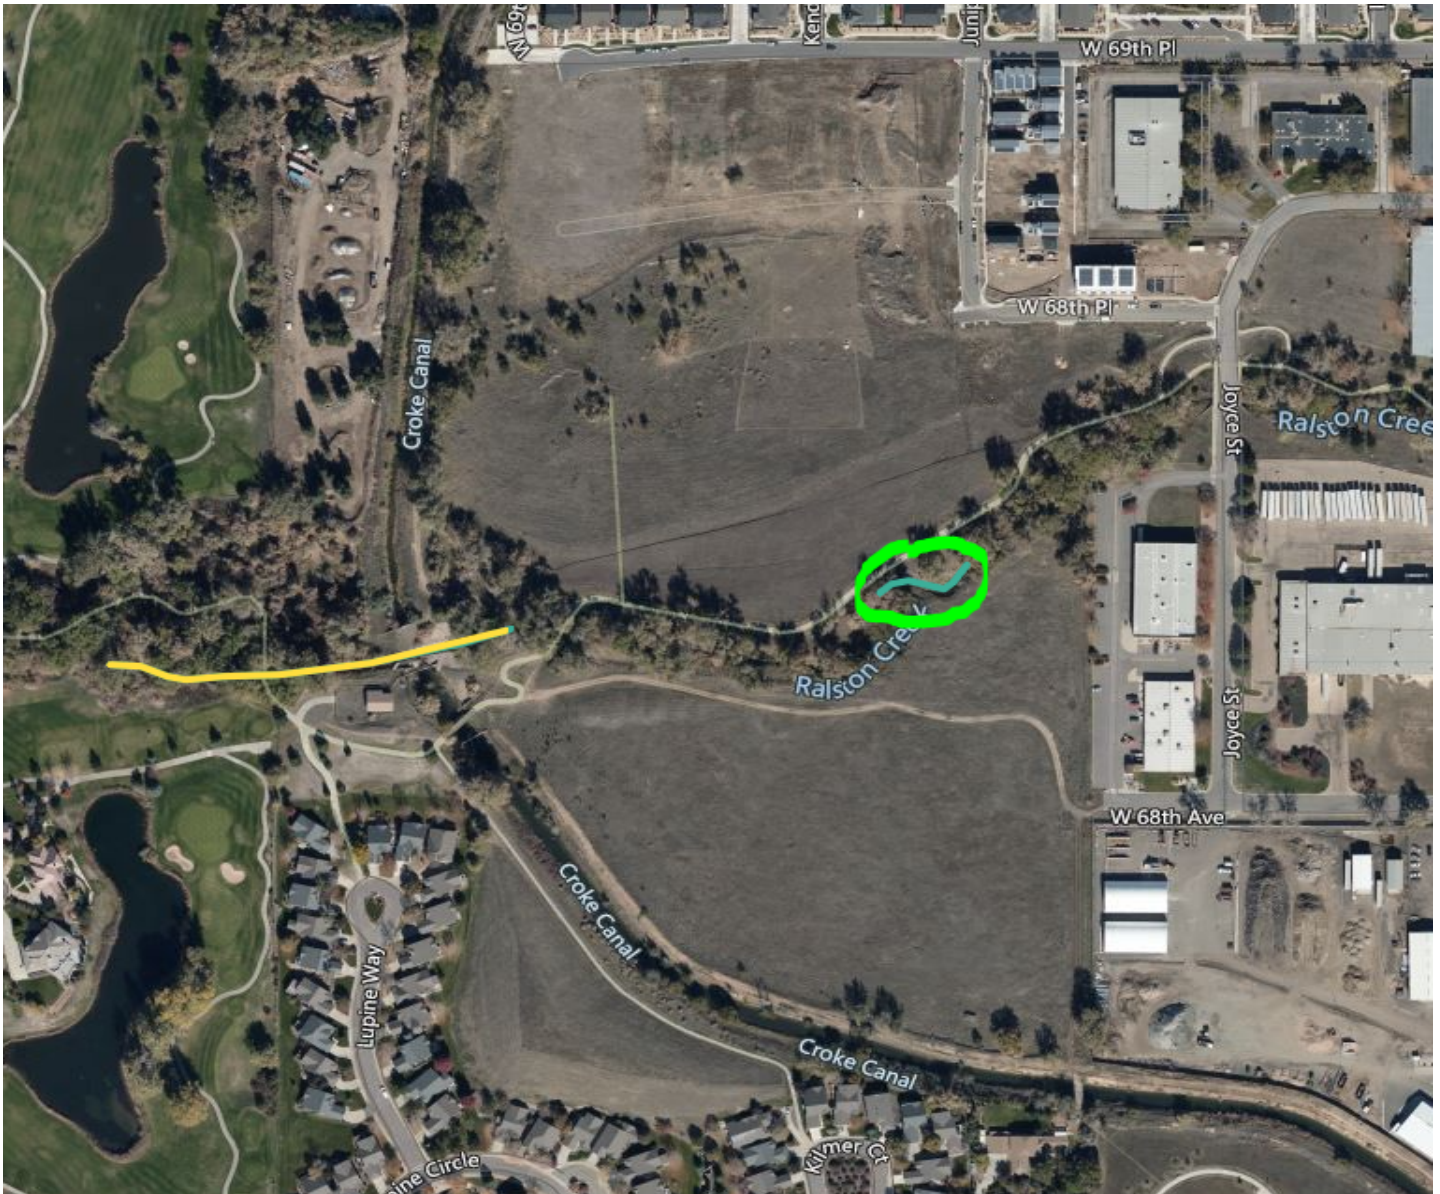
Erosion along the south bank of Ralston Creek within the property boundary has the potential to result in landfill debris being exposed and impacting the surface waters of the stream segment. In order to mitigate this exposure pathway, streambank stabilization will be conducted on segments of the streambank within the property that are determined to be impaired. The streambank stabilization efforts **may include** removal of some existing vegetation, **regrading of the streambank elevations, placement of appropriate geotextile or natural fiber erosion control systems**, and planting of native plants suitable to revegetate the disturbed areas. The streambank stabilization plan will be designed by Terracon based on observed streambank conditions at the time of development, with input from the Mile High Flood District. The appropriate state and/or federal permits will be acquired prior to initiation of streambank stabilization work.

MHFD constructed bank repairs on Ralston Creek in this vicinity during the summer/fall of 2014. The record drawings illustrating what was constructed are publicly available here: [AS-BUILT - RALSTON CREEK UPSTREAM OF JOYCE ST BANK REPAIR](#) (other documents are available from our [Document Search By Stream Webmap](#)), but the specific stretch of the Creek is a bit tough to look at with those drawings.
