July 5, 2024

Chelton, LLC
PO Box 460010
Fort Lauderdale, Florida 33487

Re: Former Kilmer Landfill Streambank Survey and Restoration
Technical Memorandum
Project Number 25237279

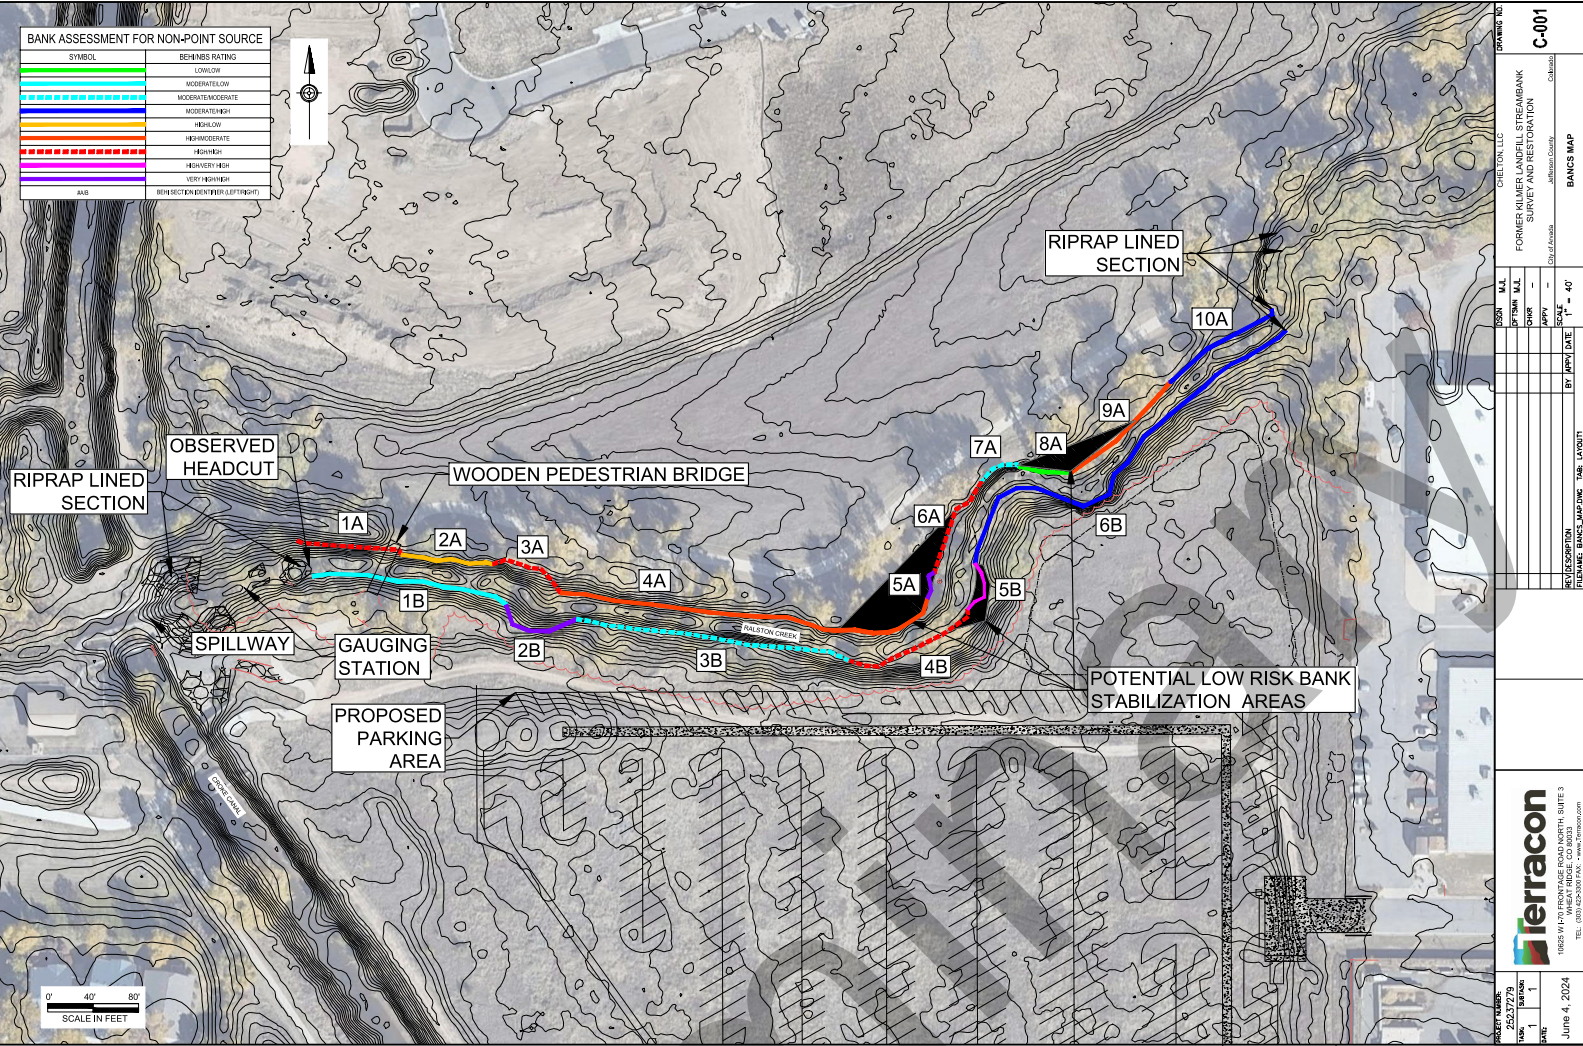
BANCS MAP

channel incision is causing an undercut in the banks. This is threatening the stability of the stabilization work and the biodegradable erosion control blankets are exposed. 5B has the most significant erosion within the previously repaired sections. Blankets along 5B were observed 4 feet above the water surface. Section 8A is stable and in good condition.

Sharp meanders were observed throughout the reach. The highest rates of erosion were observed along sharp meanders. These meanders are predicted to be a result of historic grading and the presence of tree roots. Layers of gravel bed material were observed at the historic elevation of the streambed. The meander at section 5B contained a relic gravel streambed layer that is over 3 feet higher than the current channel invert. This indicates the channel has eroded over 3' vertically within this section since previous stabilization efforts.

The root causes of instability within the reach were identified as valley confinement and low radius of curvature (sharp corners along the meanders). These causes cannot be repaired without significant impacts to adjacent land use and the mature forest stand. Impacts would include potential exposure of utilities, relocation of pedestrian trails (because of the need of laying back the streambank grading at stable slopes), exposing previously closed landfill material along the right bank, removing mature trees (some greater than 6' diameter at breast height) which would subsequently eliminate shading, existing bank and channel protection, and habitat.

Areas identified for stream bank improvements without impacting mature trees is limited. Section 5B could benefit from bank stabilization efforts including grading that would not significantly impact mature trees nor exacerbate the root causes identified. A larger segment of the study area could be improved by installing live stakes if plant establishment could occur prior to bank failure as seen in previous efforts.

It is recommended that the channel be monitored again in three years to observe the changes in the stream channel to estimate the long-term trend. If the stream continues to actively degrade to the point that it threatens infrastructure and mature trees are lost due to degradation, a restoration or stabilization could be justified. Conversely, the surface protection provided by the tree roots could arrest further erosion or the stream could evolve to a stable condition through bank widening and collapsing as depicted in Rogen's stream evolutionary predictions. The long-term trend should be verified prior to advancing stabilization efforts that may be ineffective or cause greater harm to the reach.

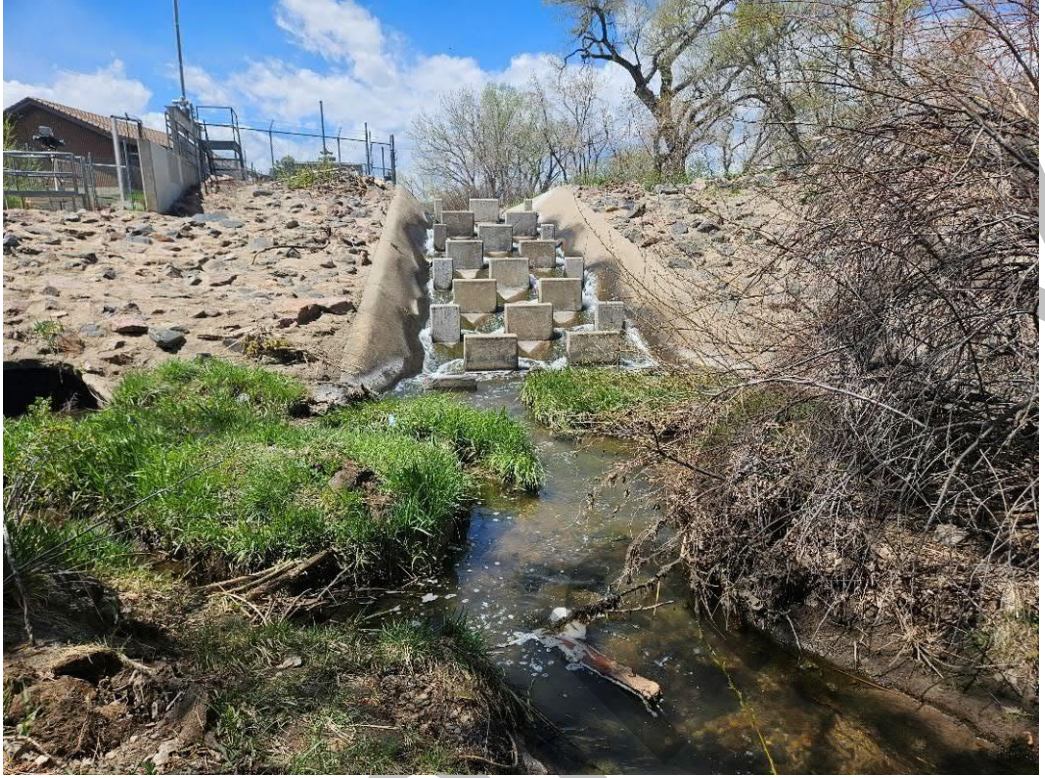
<p>Photo 1</p>

<p>Date: 4/24/2024</p>	
<p>Description: Facing upstream viewing spillway of Ralston Creek over Croke Canal.</p>	
<p>Photo 2</p>
